Transportation Pooled Fund-5(522), PG3

Joel Uling, Pavement Preservation Engineer
Office of Materials and Road Research

Minnesota PG3 Pavement Preservation Treatment
March 20, 2025

Scrub Cape Seal

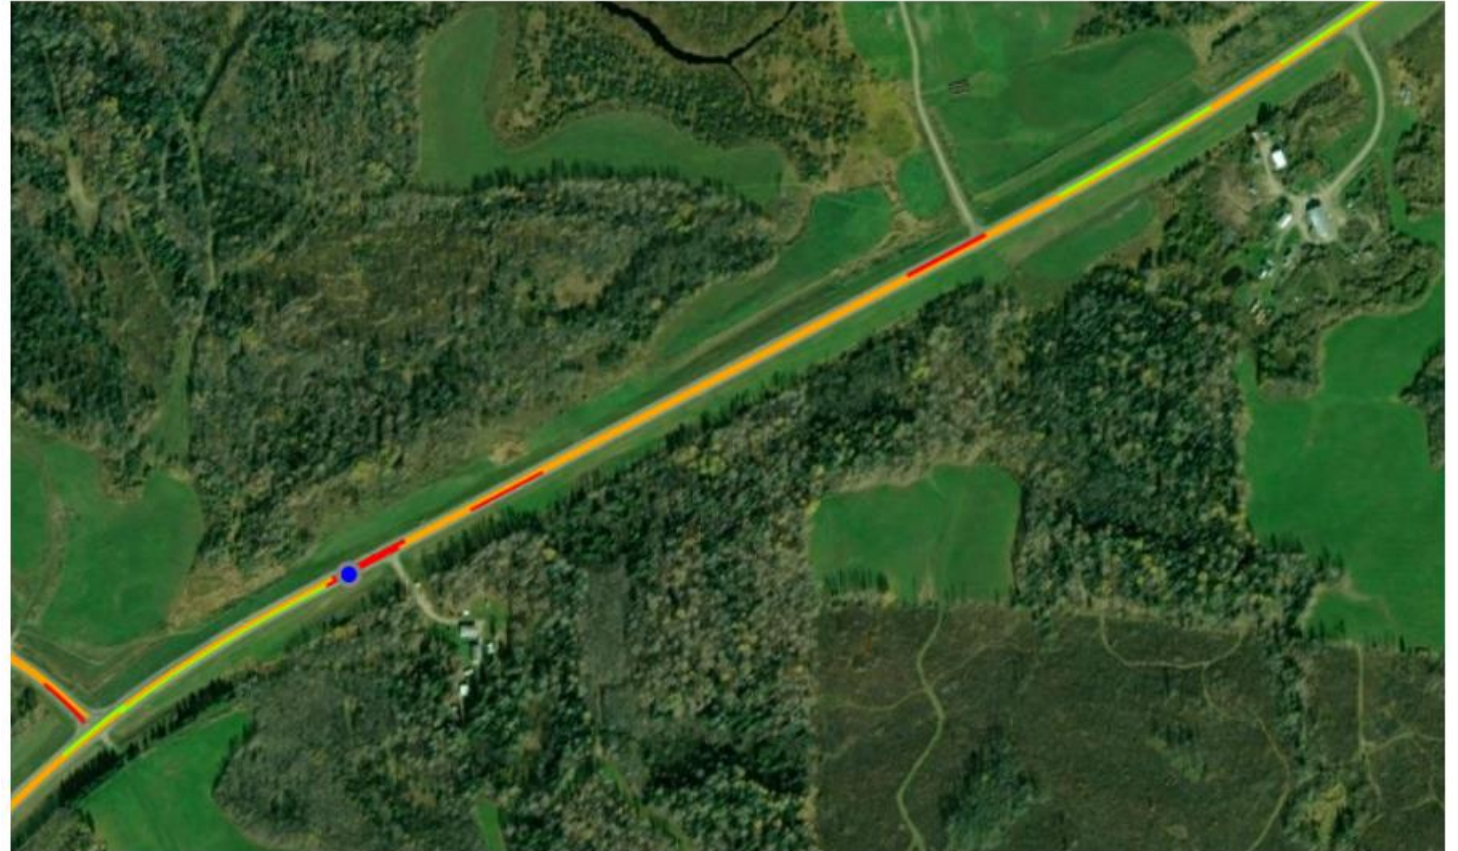
IRI Data

Average IRI

- Severe: Greater than 220
- Moderate: Between 110 and 220
- Good: Less than 110

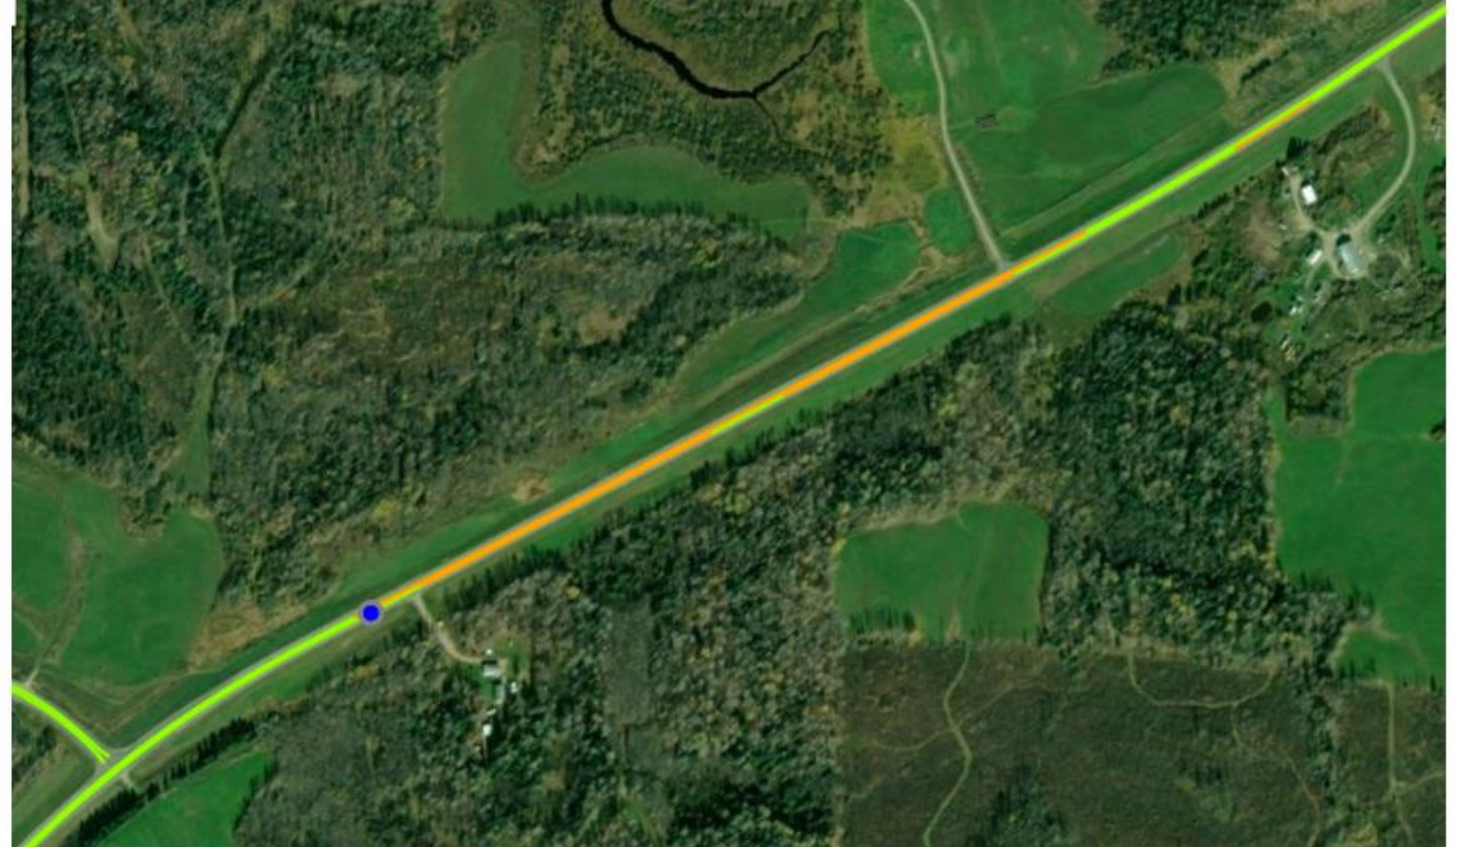
Rutting Data

Average Rutting

- Severe: Greater than 0.5"
- Moderate: Between 0.25" and 0.5"
- Good: Less than 0.25"
